# Assessing Natural Resource Impacts from the Enbridge Pipeline Spill into the Kalamazoo River

# Presentation Outline

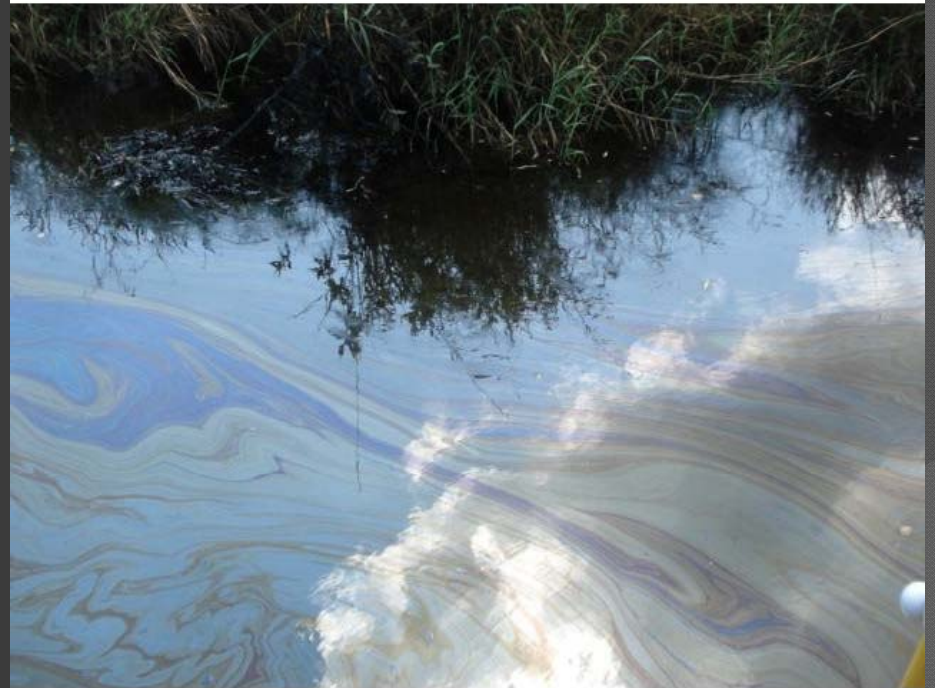
2010\_0805\_Team2\_photoset2

N 42.299129° W 085.130797°

08/05/2010 3:02:13 PM

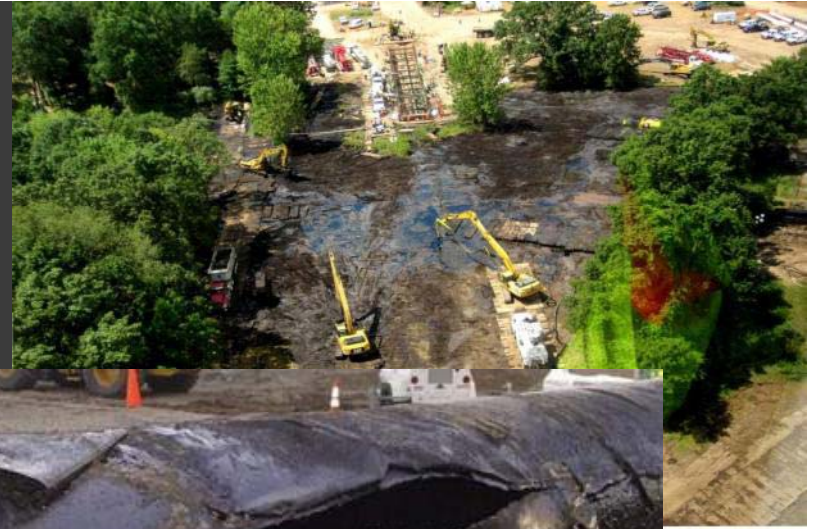
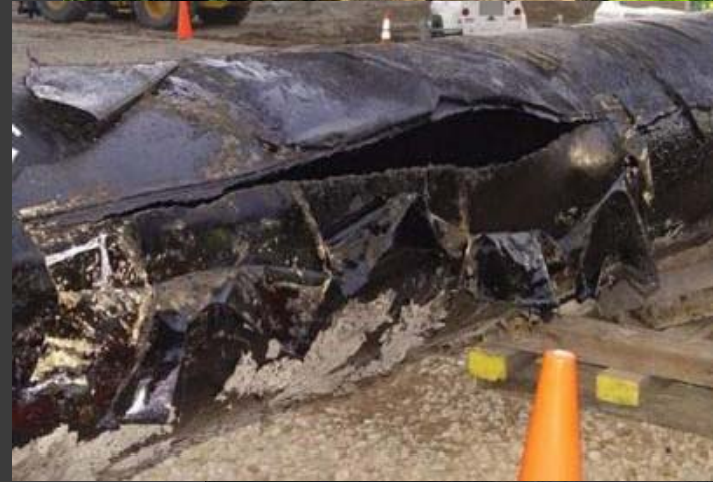
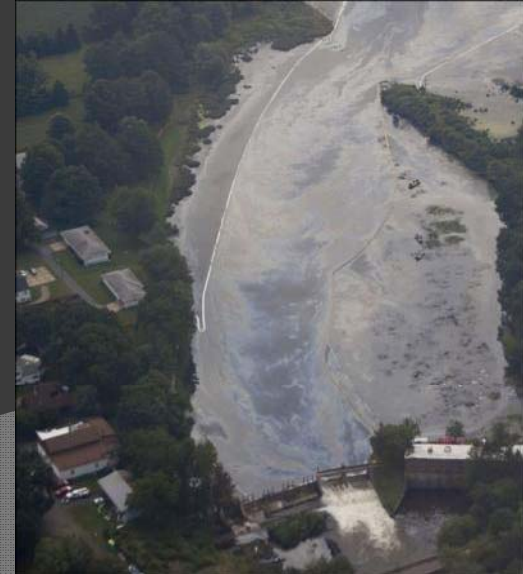
- 30" underground pipeline ruptured on July 25, 2010
- Approximately 1 million gallons of tar sands crude oil released
- Oil seeped through wetland soils into a creek tributary to the Kalamazoo River

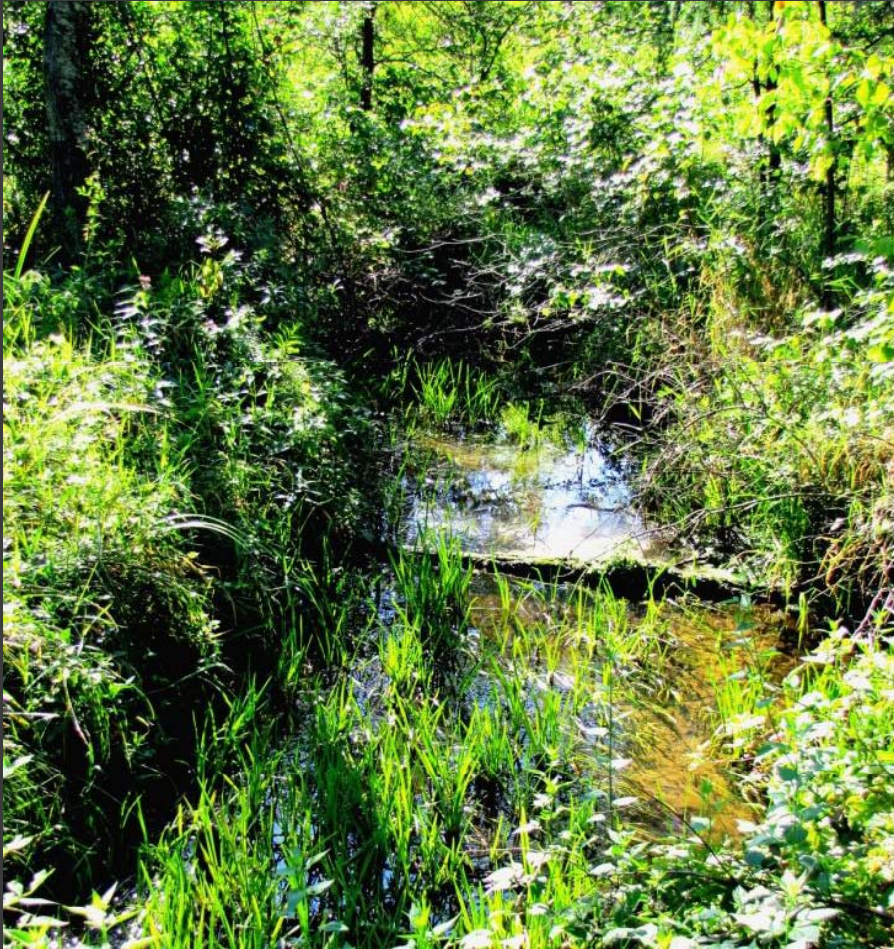
- Upstream reference site on Talmadge Creek

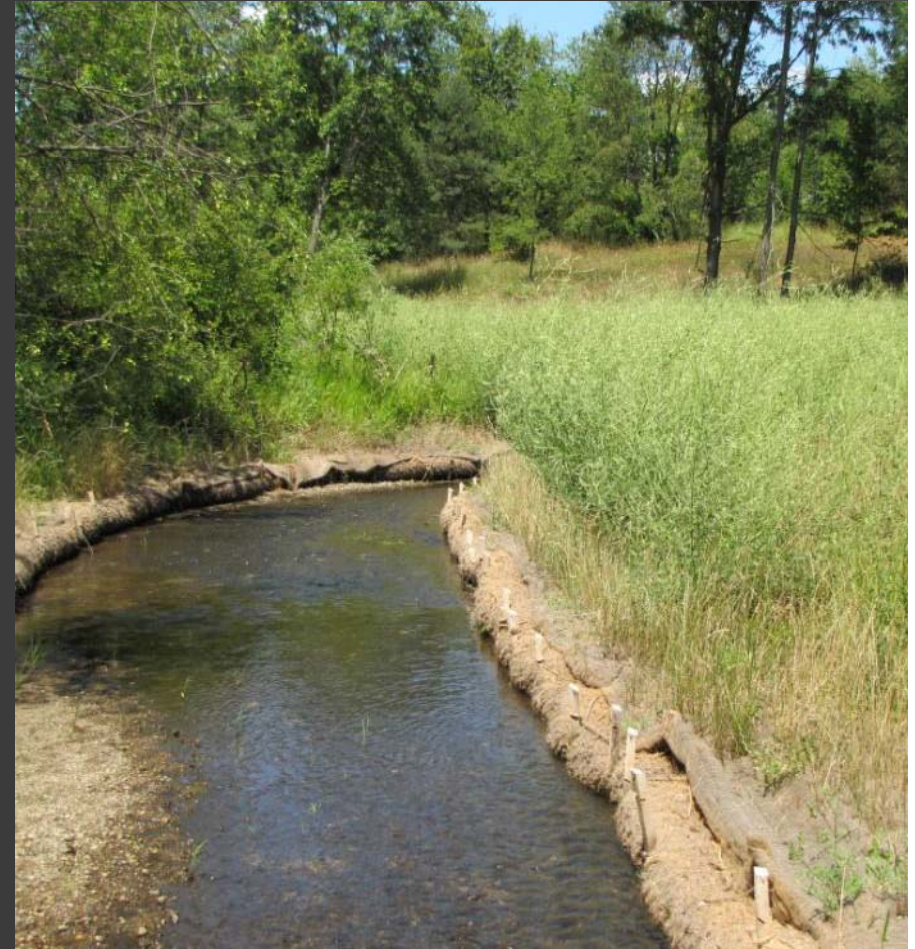
- Impacted site on Talmadge Creek (excavated to remove oil)

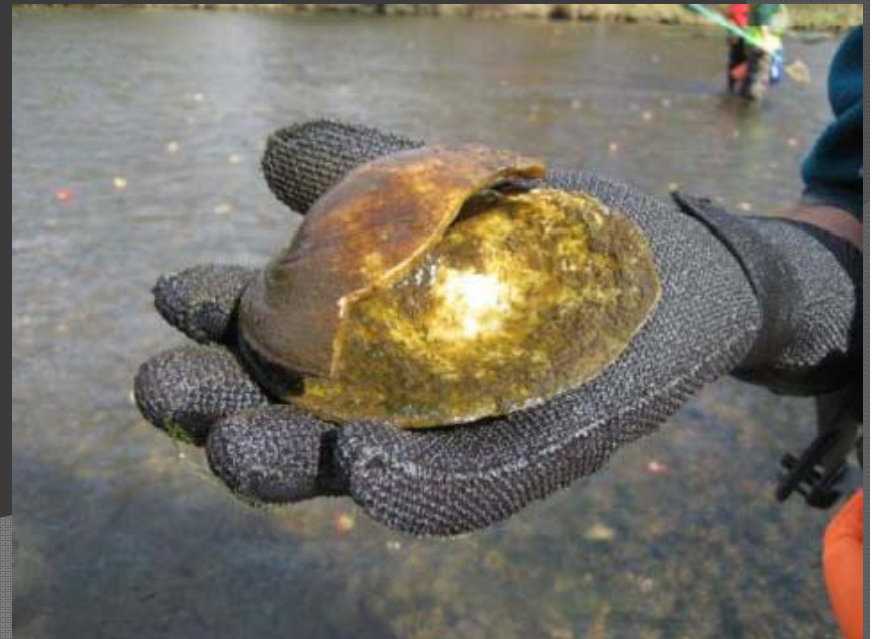
- Assessed physical condition of post-mortem mussel shells:
  - Broken vs. crushed
  - Degree of weathering, ranging from “fresh dead” to “heavily worn”
- 18 species documented
- Crushed and freshly dead shells found within spill area but not in reference area
