Liquid Asphalt Releases in Aquatic Environments Workshop

Case Study #1 – CSO Barge

Chicago Ship & Sanitary Canal – January, 2005

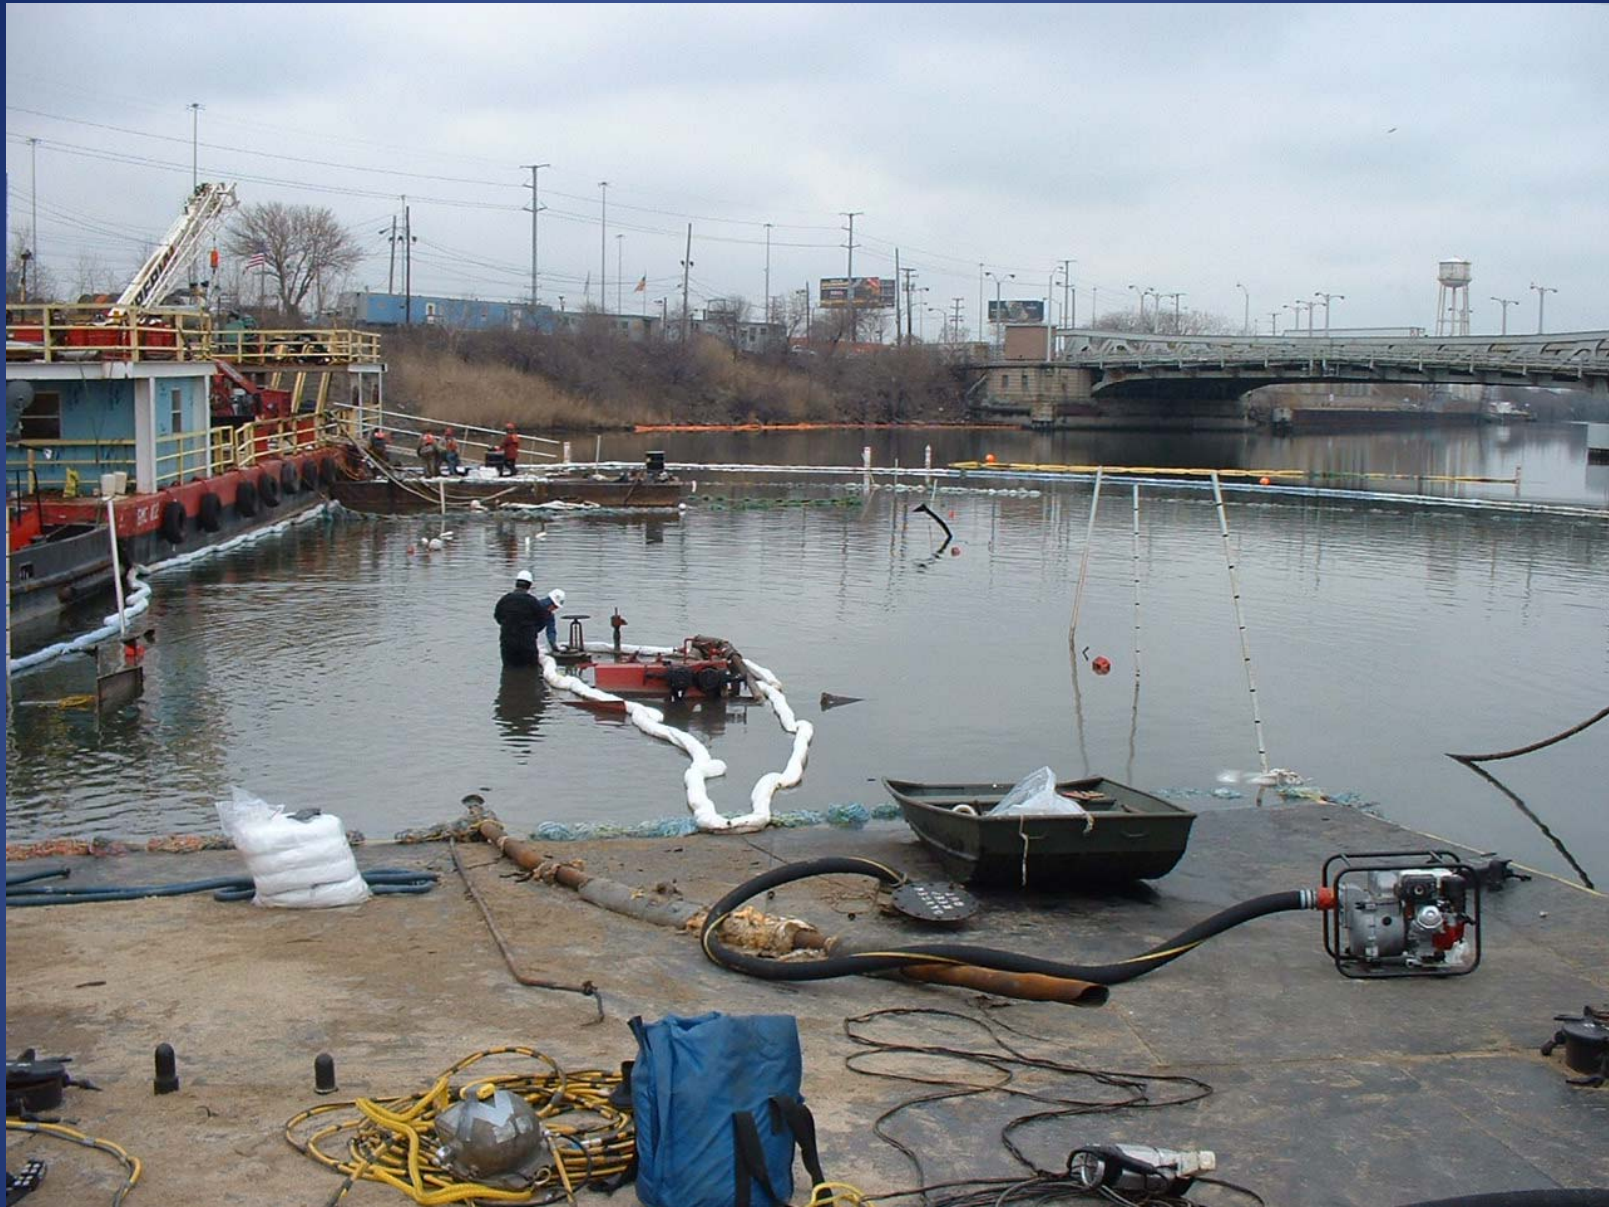
Photo taken from the exposed bow of the barge, with the stern ~295' to the rear and under ~20 feet of water. At this point, all oil is thought to remain on board.

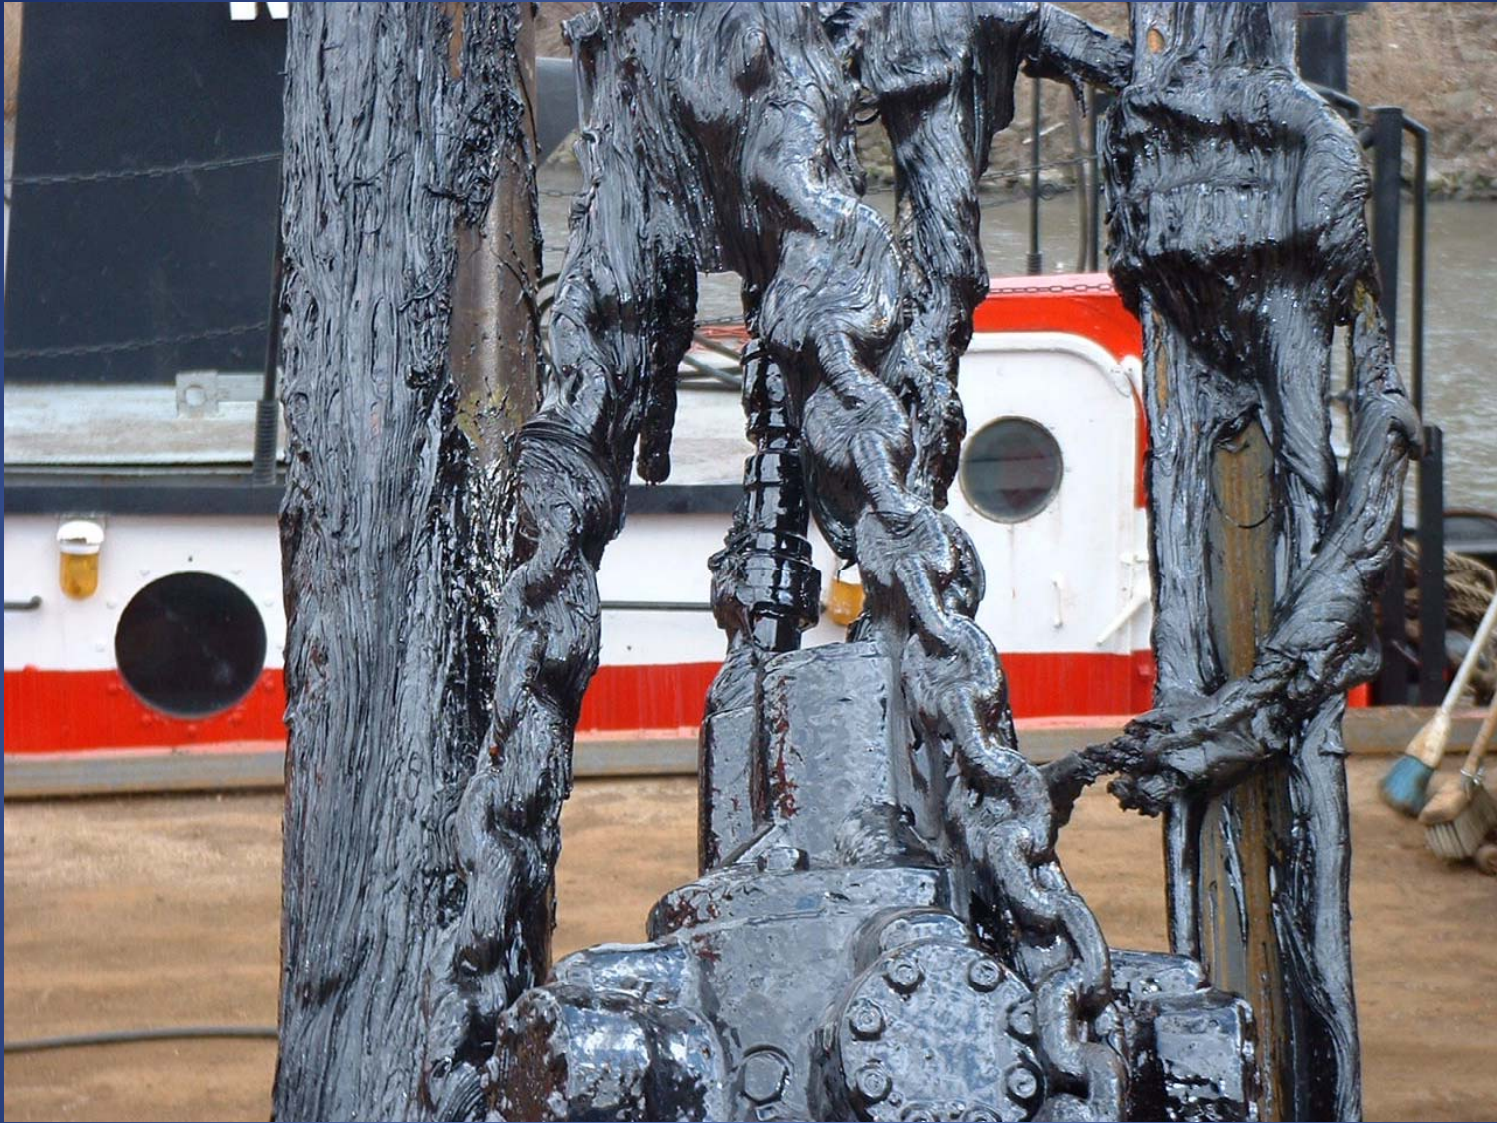
When exposed to cold air (ambient temperatures were below 20 degrees F) the CSO immediately solidified and could not be pumped unless heated again.

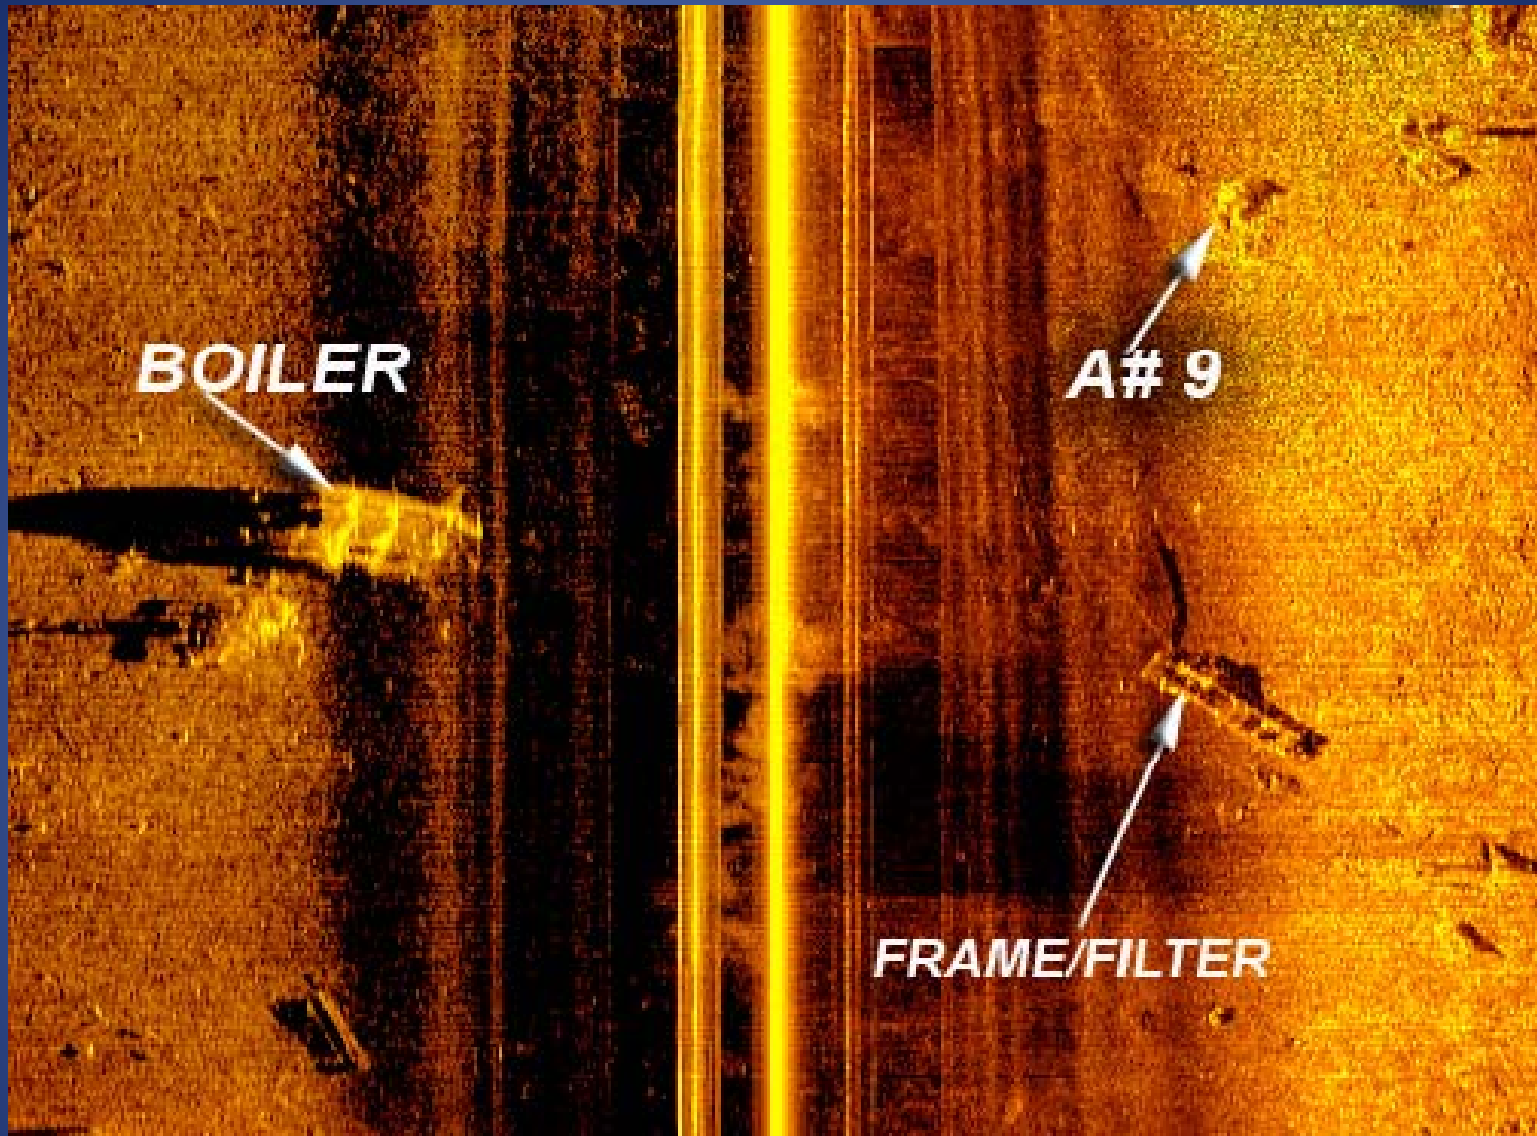
Side scan sonar proved very useful for debris recovery purposes. However, the planning team did not find this technology useful for locating oil on the bottom of the canal and instead relied on divers' visual observations.

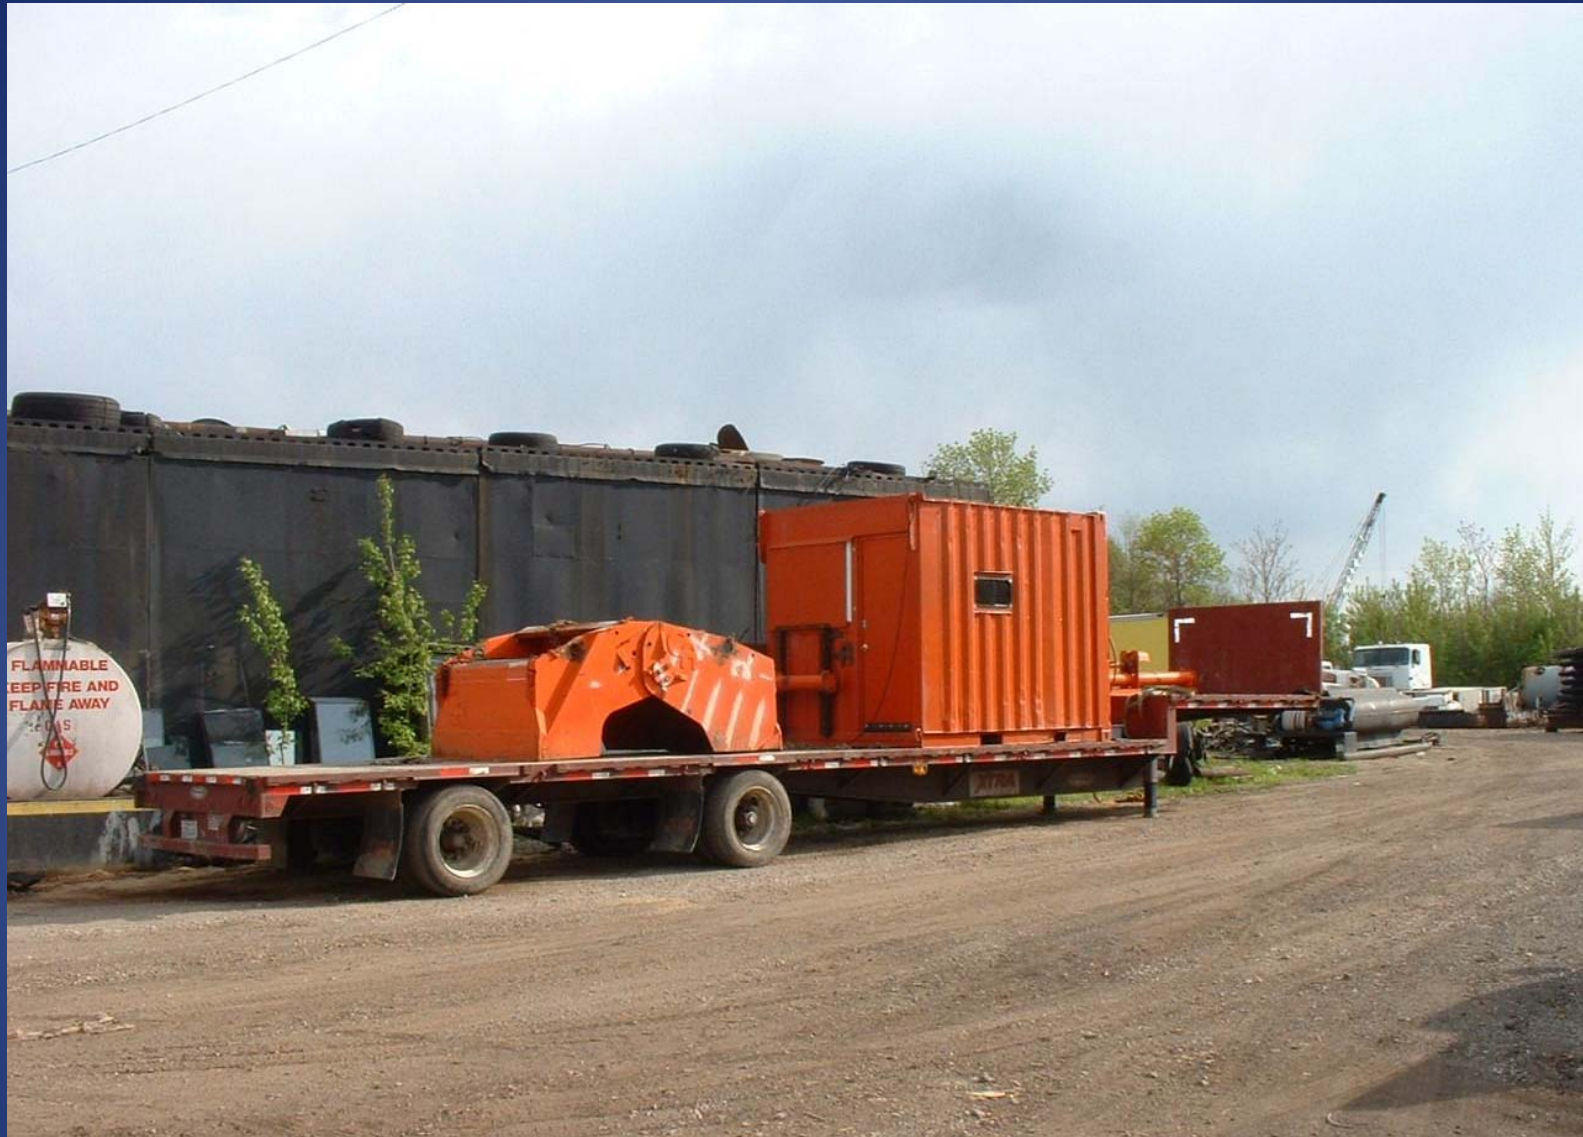
After considering a number of different approaches, this environmentally-friendly clamshell dredge unit was mobilized to the site. The dredge minimizes the amount of contaminated water runoff associated with such operations.

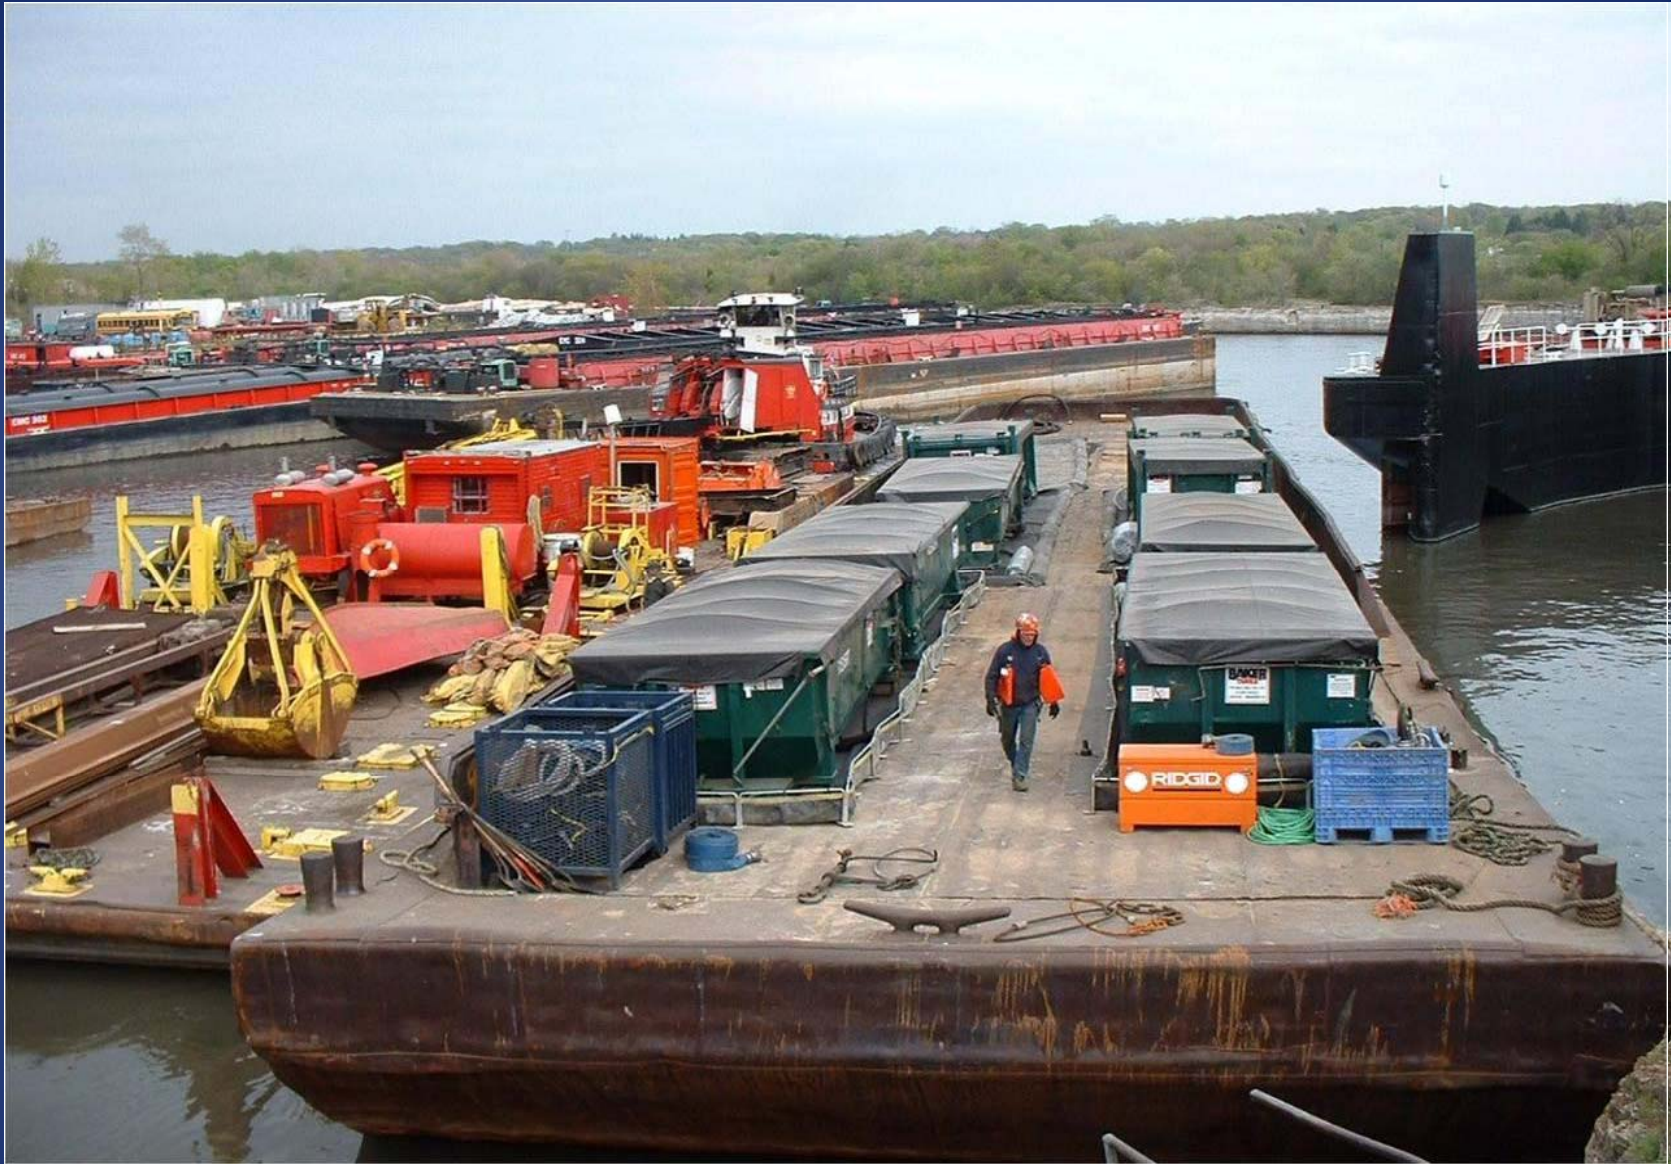
Two platform barges were sourced and obtained, one and was outfitted with a series of recovery boxes (20 cubic yard – DOT-approved). The boxes were sealed with waterproof foam at their doors.

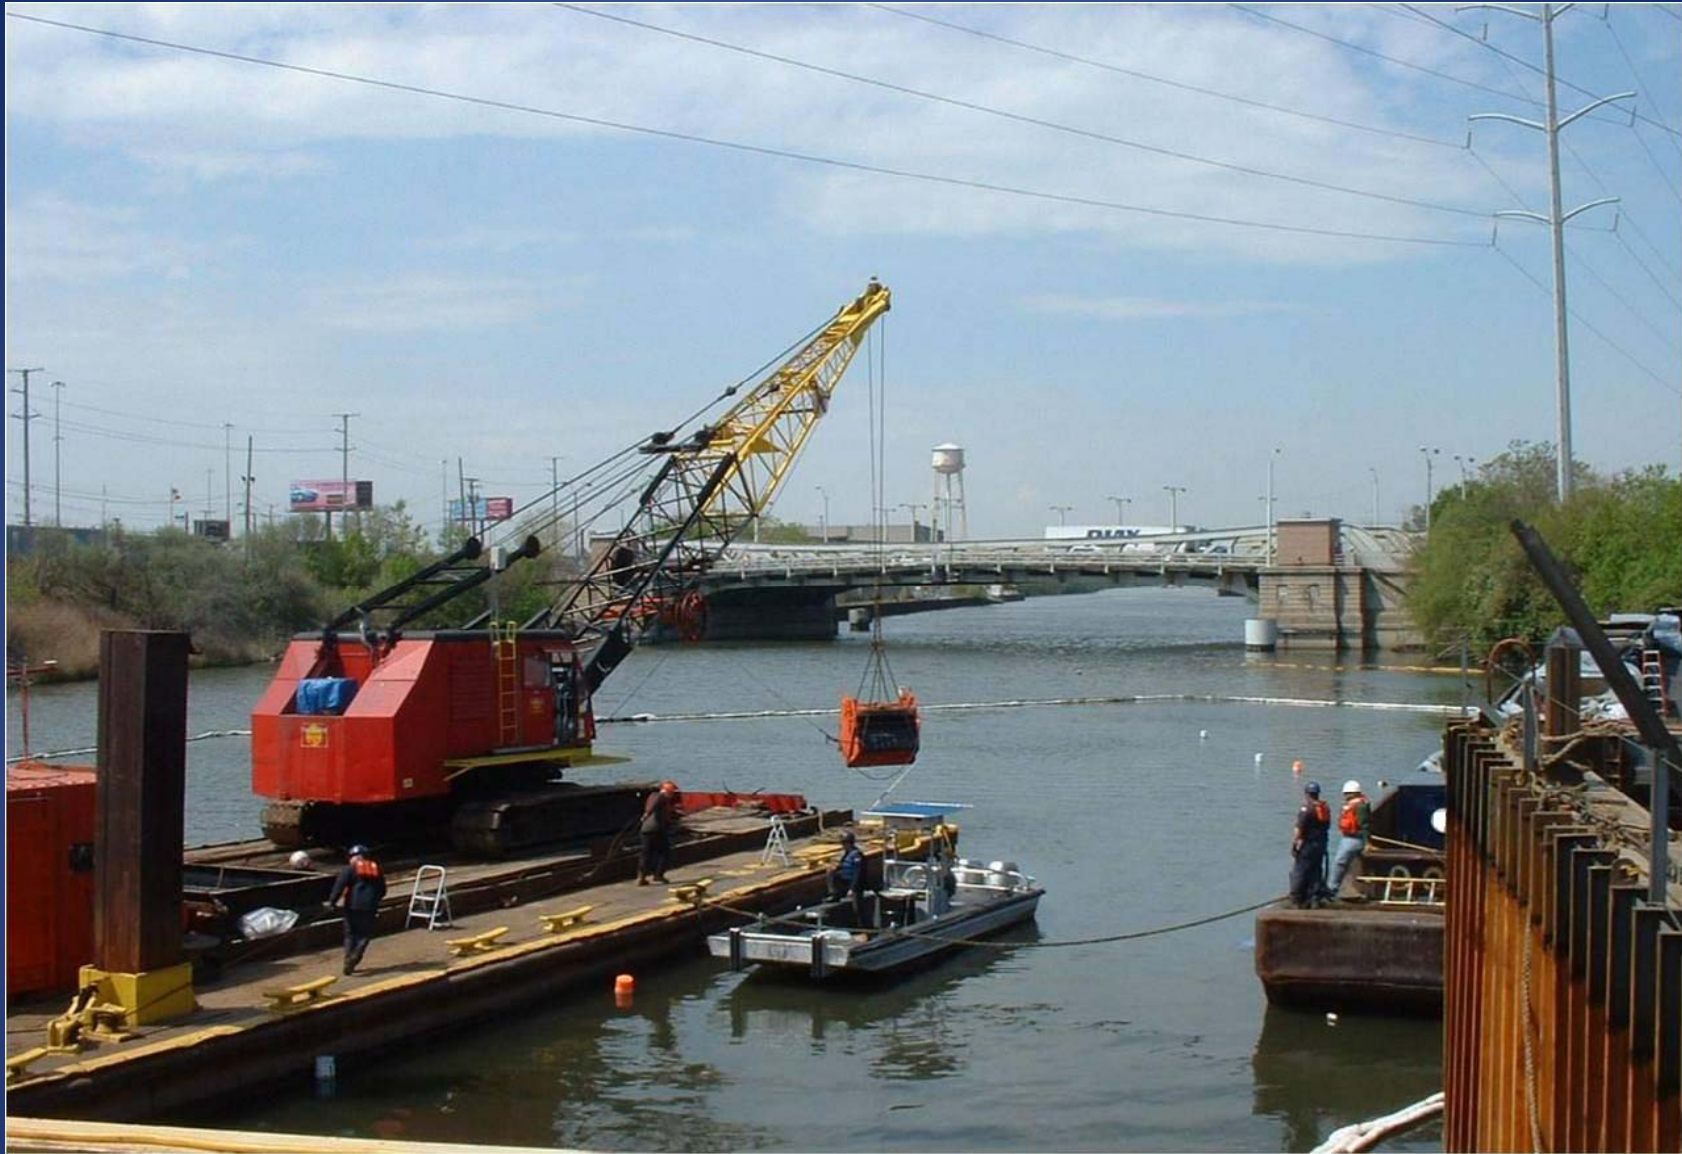
The second barge housed the crane unit that was used to deploy the environmental clamshell bucket. The second barge also housed the GPS system analytical processing center and computers.

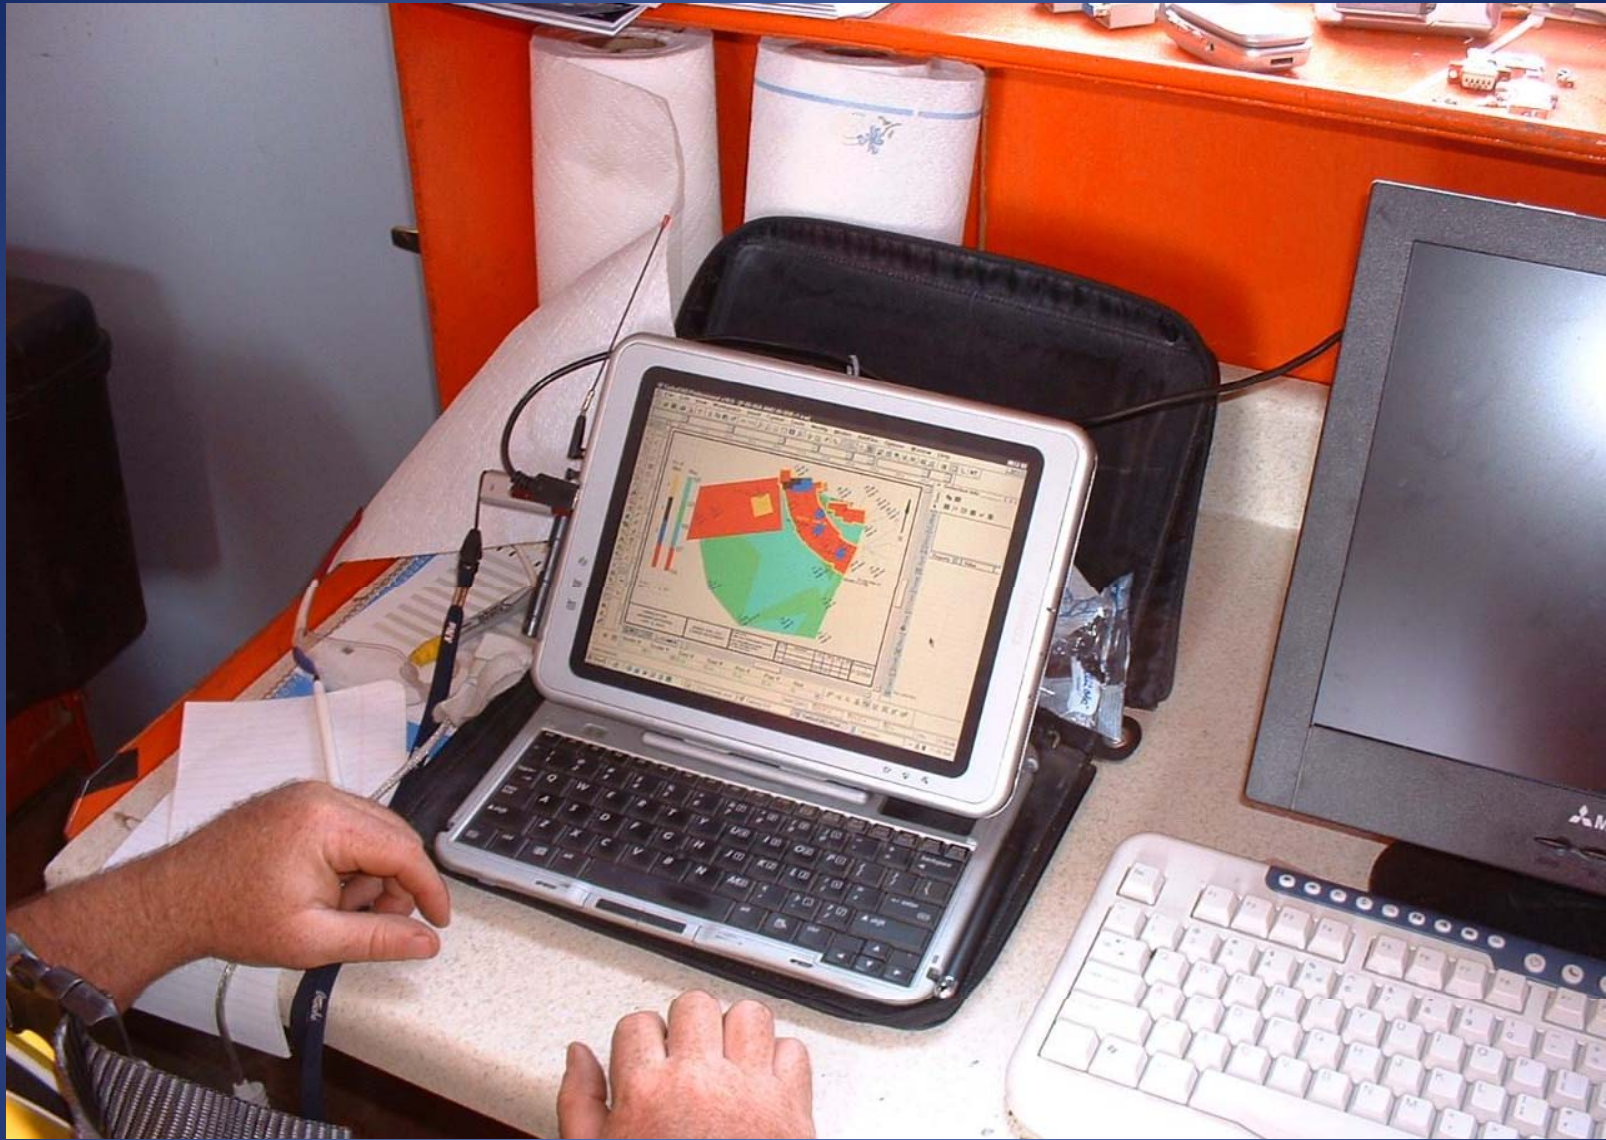
Each “bite” taken by the crane was recorded in an electronic format, and a map representing daily progress was submitted at the close of each day’s operations.
